Assessing prosthetic mitral valve regurgitation by transoesophageal echo/Doppler

Heart 2004;**90**:476–478. doi: 10.1136/hrt.2003.026484

Congenital coronary artery anomaly demonstrated by three dimensional 16 slice spiral CT angiography

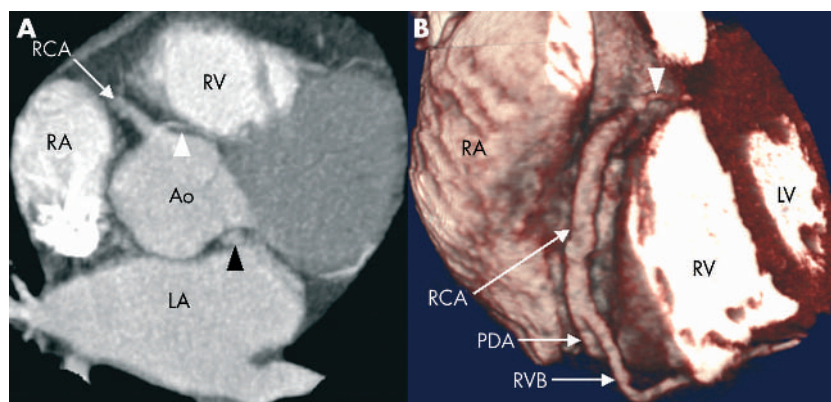
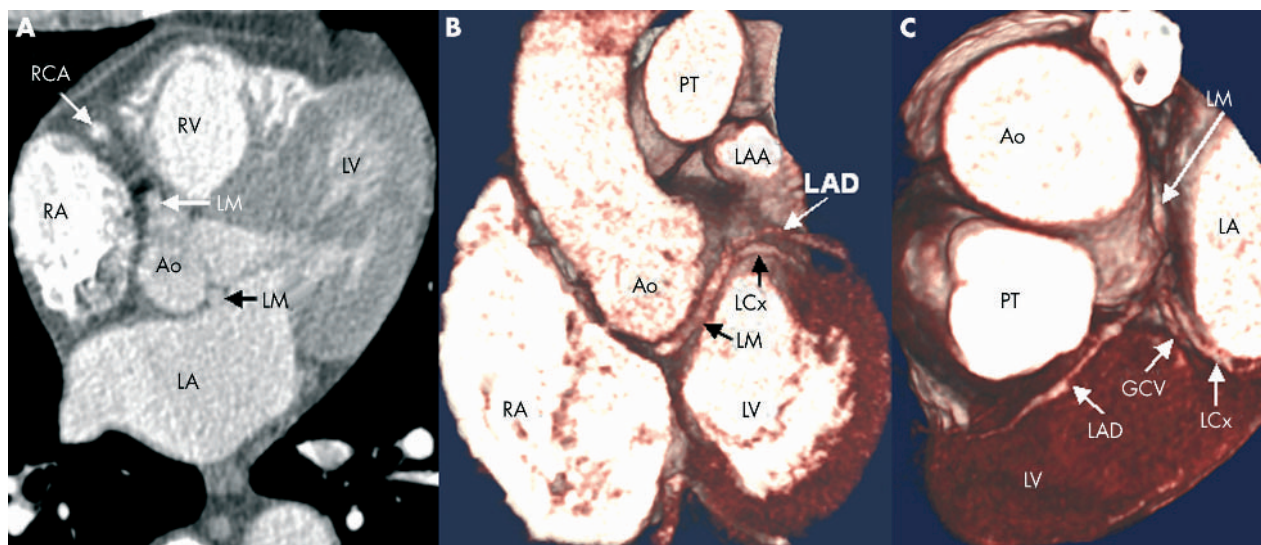
The left main coronary artery had an anomalous origin from the right, anterior sinus of Valsalva originating just above the right coronary artery ostium and followed a benign, retroaortic

course (black arrowhead) after which it bifurcated into the left circumflex artery and a small left anterior descending artery (lower panels A–C: Ao, aorta; GCV, great cardiac vein; LA, left atrium; LAA, left atrial appendage; LAD, left anterior descending artery; LCx, left circumflex artery; LM, left main coronary artery; LV, left ventricle; PDA, posterior descending artery; PT, pulmonary trunk; RA, right atrium; RCA, right coronary artery; RV, right ventricle; RVB, right ventricular branch). The first septal perforating artery (white

arrowhead) arose just anterior to the right coronary artery ostium (upper panels A and B), consistent with the x ray angiogram. The dominant right coronary artery bifurcated into the posterior descending artery and right ventricular branch at its mid distal portion. As CT findings excluded malignant coronary anomaly, there was no need for surgical intervention.
